Subject: The Bulb Eater<sup>TM</sup> Model 55 VRS Mercury Emissions' Sampling and Evaluation Report

**The Bulb Eater™ Model 55 VRS**  
**Mercury Emissions' Sampling and Evaluation Report**

# **Bulb Eater™ Model 55 VRS (Navy Prototype)**

## **Mercury Emissions' Sampling and Evaluation Report**

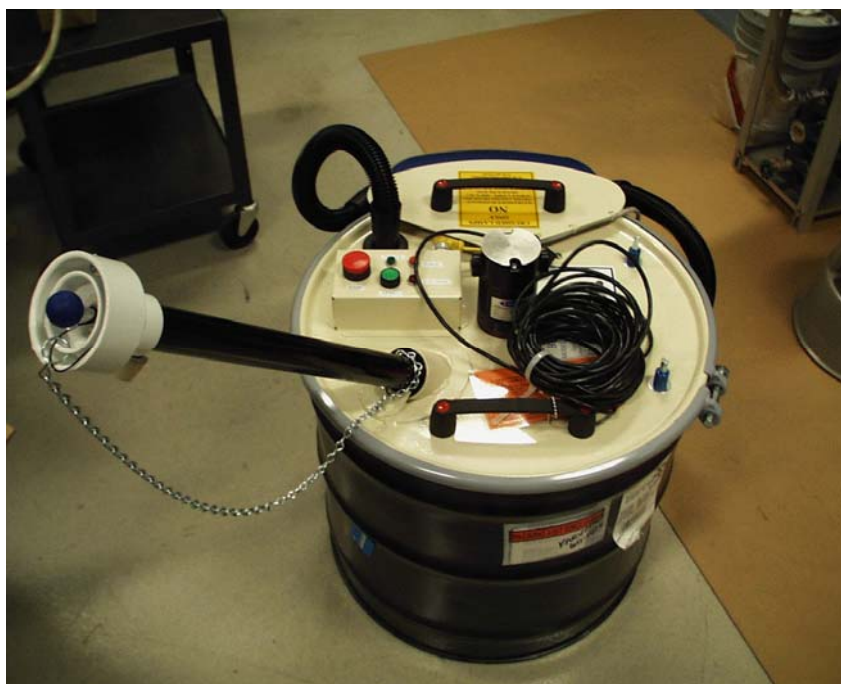
**Figure 1. The Bulb Eater™ Model 55-VRS**

Air Cycle Corporation made many mechanical integrity improvements during the latter half of 2002 to eliminate mercury emissions at potential leakage points (e.g. connections, fittings, attachments, etc.) as a result of mercury emission concerns by the U.S. Navy. Also newly developed for the system is the addition of a 10" storage drum for attaching the unit when not in use. The storage drum prevents phosphor and mercury particulate residue on the chain side of the unit from contaminating the storage area when not in use and when not mounted atop a 55-gallon waste drum. The 10" storage drum also saves space when the unit is stored. Air Cycle Corporation also improved the system further by including an air purge cycle that will run the vacuum pump for 7 to 10 seconds after the machine is turned off, a drum open sensor that cuts off the motor if the drum lid is opened, and a new control panel complete with indicator lights. The result of these efforts is the Bulb Eater™ Model VRS system. Figure 1 displays the Bulb Eater™ Model VRS system atop a 55-gallon crushed lamp waste drum.

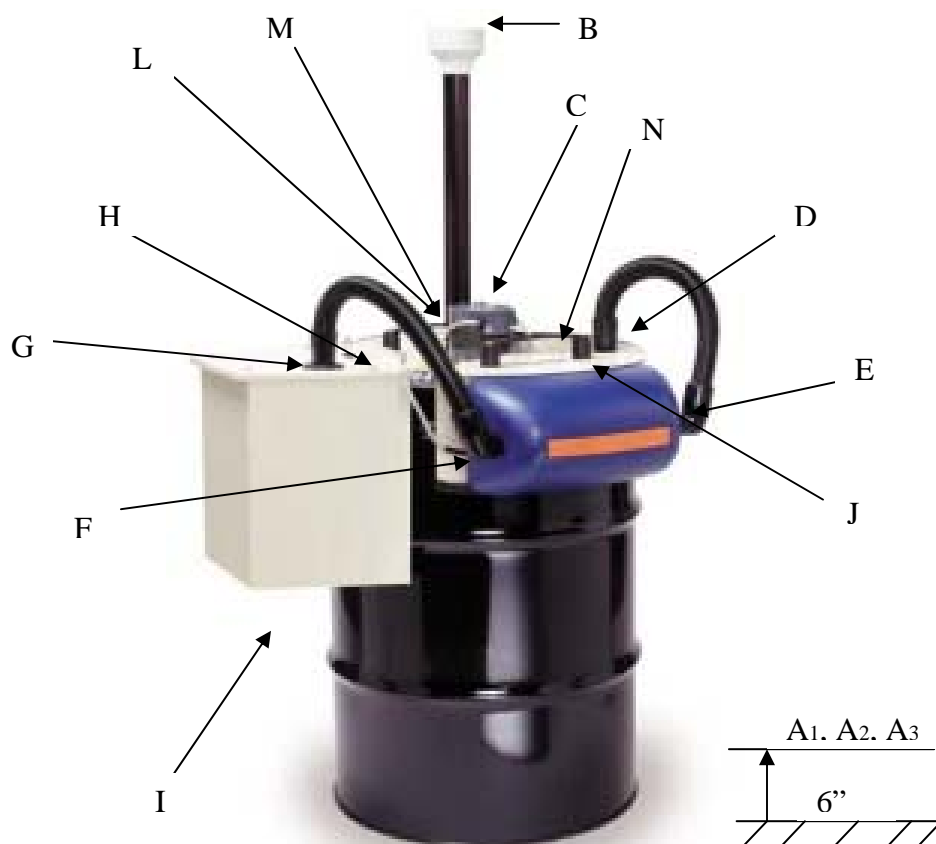
The Bulb Eater<sup>TM</sup> direct reading instrument primary sample locations are presented in Figure 2. Other areas on the unit were sampled as a result of smoke tube tests.

Figure 2. The Bulb Eater™ Model 55 VRS (Navy Prototype) Sample Points	
Sample Point	Description
A <sub>1</sub>	Ambient Hg concentration before test cycle, 4-6 inches above floor
A <sub>2</sub>	Ambient Hg concentration after test cycle, motor on, 4-6 inches above floor
A <sub>3</sub>	Ambient Hg concentration after A2 sample collected, motor off, 4-6 inches above floor
B	Fluorescent lamp chute entry point
C	Motor housing area
D	HEPA filter air hose connection exit from drum top lid
E	HEPA filter air hose connection entry to HEPA filter housing
F	HEPA filter air hose connection exit from HEPA filter to carbon filter
G	HEPA air hose connection entry to carbon filter
H	Carbon filter housing lid rim area
I	Fan exit air stream
J	Drum lid rim near HEPA filter
K	Drum lid rim area near carbon filter
L	Fluorescent lamp chute entry connection to drum top
M	Drum lid rim area opposite HEPA filter
N	Drum lid rim area opposite carbon

OBZ	Operator breathing zone (not shown in Figure 5.)

Figure 2. The Bulb Eater™ Model 55 VRS (Navy Prototype) Sample Points	
Sample Point	Description
Other	Other areas as indicated by smoke tube testing (e.g. HEPA filter housing seams)

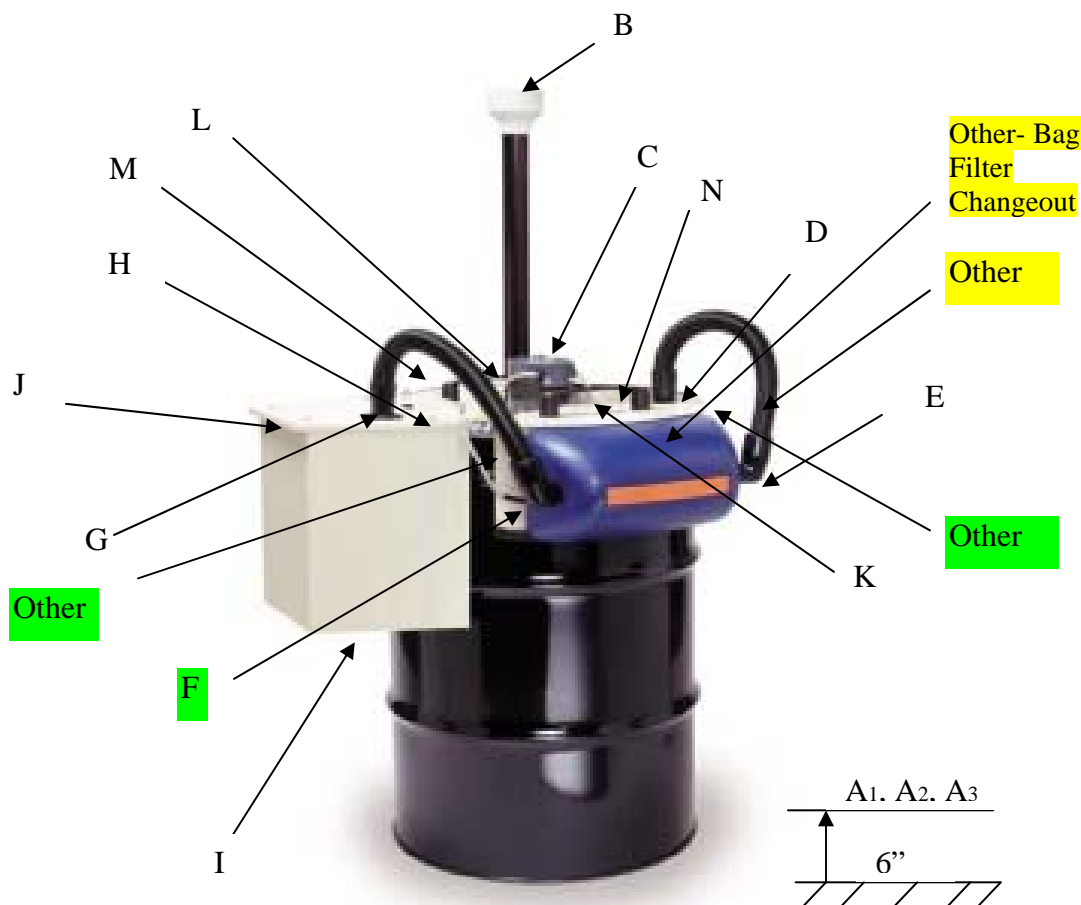
A summary of the Jerome Mercury Vapor Analyzer DRI sample results (i.e. real time 10-second integrated DRI readings) during operations of the Bulb Eater™ Model 55VRS (Navy Prototype) is presented in Figure 3. The sample point letter-designators and mercury vapor measurements highlighted in yellow reveal locations on the where mercury vapor concentrations exceeded the ACGIH TLV-TWA equal to 0.025 mg/m<sup>3</sup>. The sample measurements highlighted in the color green reveal locations on the Bulb Eater™ where mercury vapor concentrations equaled or exceeded the OSHA PEL-TWA equal to 0.100 mg/m<sup>3</sup>. DRI measurements were made within

**Figure 3. Sample Locations Depicting Mercury Emissions' Areas in Excess of OSHA PEL and ACGIH TLV**

two to three inches of the unit at each of the sample points and within six inches directly beneath the air exhaust area of the Bulb Eater's emission control device.

As can be gleaned from the above tables and diagram mercury vapor concentrations exceeding the ACGIH TLV-TWA and the OSHA PEL of  $0.100 \text{ mg/m}^3$  (as real time 10-second integrated DRI readings) for mercury are associated with the HEPA filter housing area connections and seams. Additionally the mercury vapor concentrations (as real time 10-second integrated DRI readings) exceeded the ACGIH TLV-TWA for mercury in the operators breathing zone during filter bag change-out.

Drum change-out and filter replacement operations revealed the Bulb Eater™ has potential to exceed both ACGIH TLV-TWA and OSHA PEL-TWA mercury vapor exposure limits. These operations include the Bulb Eater™ unit removal from the full crushed lamp collection drum, full crushed lamp collection drum lid removal, and full crushed lamp collection drum lid replacement and tightening, and during filter unit change-out and replacement. Additionally, the full waste drums are likely to be contaminated with mercury particulate at the end of crushing operations.
